MISCELLANEOUS PAPER S-68-14

PROJECT ALTAIR KWAJALEIN, MARSHALL ISLANDS STATIC AND DYNAMIC RESPONSE OF A RING-BEAM ANTENNA FOUNDATION

D. R. Casagrande

July 1968

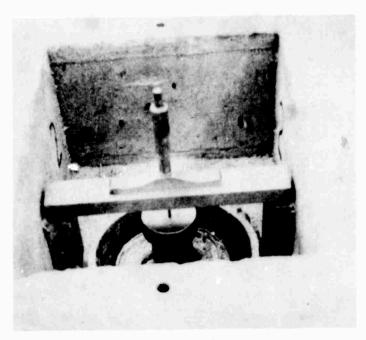
- 25. The gage 1 readings taken subsequent to the initial reading incorporate a slight error because one of the support blocks broke loose twice and was reepoxied to the concrete. However, the gage has been operational since July 1967 and the readings, when compared with those of gage 2, indicate that presently the reference bar may be about 0.005 in. lower than its original position.

Photograph 5. Settlement gage

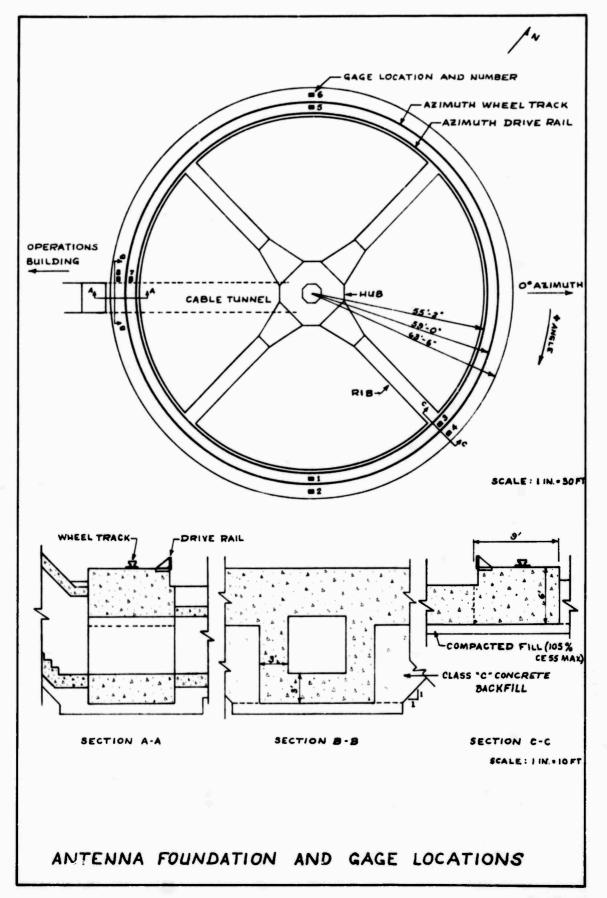
PLATE 3

- 17. Readings at all eight gages could not always be recorded due to either gage malfunction or inaccessibility. Gage 3 (see plate 3) was intermittently inaccessible during the construction period, and gage 4 was rendered permanently inaccessible in mid-May 1967 by a steel plate of the antenna stow mechanism. Gage 1 became inoperable twice, but was repaired and has been operational since July 1967. Gage 7 became inoperable in July and was not repaired until February 1968.

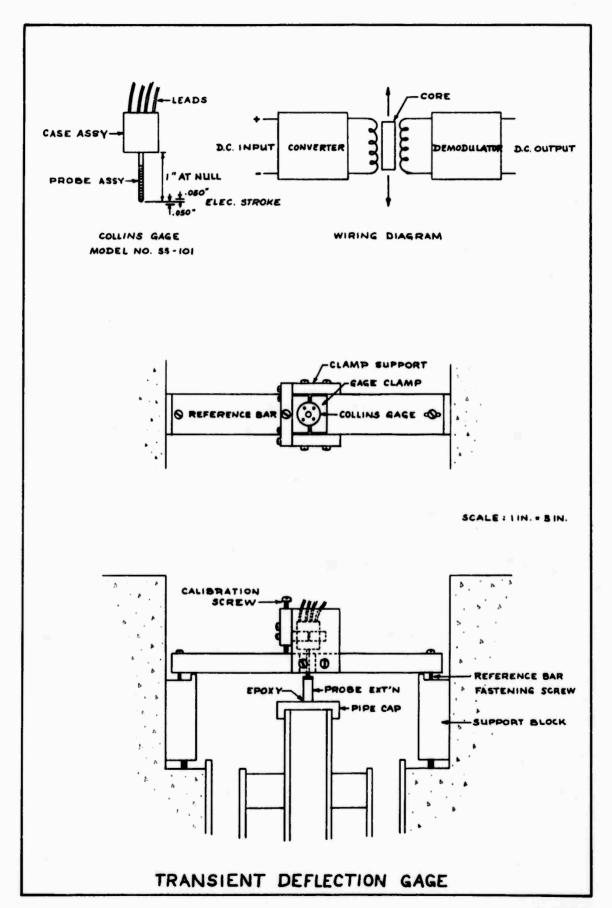
PLATE 5

- 14. The case assembly was clamped to the reference bar that was screwed to the support blocks, and the probe assembly was screwed into a brass extension that was epoxied to the bench-mark pipe cap (see plate 5 and photograph 6). The gages were calibrated mechanically by raising or lowering the case assembly clamp and measuring the magnitude of this

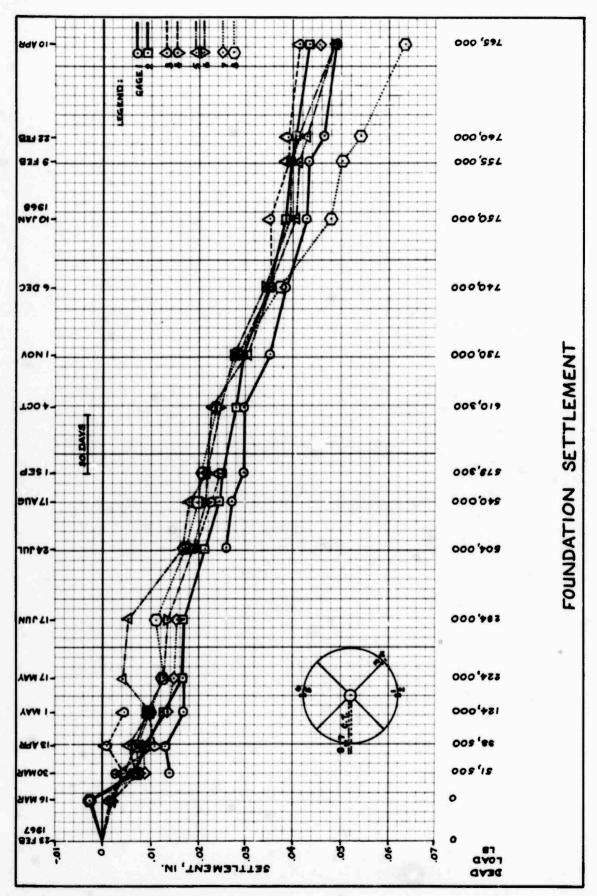
PLATE 6

- 16. The zero-settlement readings were taken on 23 February 1967, at which time there was no superstructure load on the foundation. During the one-year superstructure construction period, 765,000 lb of dead load were applied to the foundation at a rate ranging from 2,000 to 200,000 lb per month. The foundation responded by settling at an almost constant rate of 0.0037 in. per month until January 1968 when the average settlement rate decreased to about 0.0030 in. per month. The last settlement readings prior to the preparation of this report were taken on 10 April 1968, at which time all the dead load had been applied to the foundation. They indicated that the foundation had settled an average of 0.049 in. and had undergone a differential settlement of approximately 0.022 in. This was the largest recorded differential settlement and is not representative of the average differential settlement, which was approximately 0.010 in. until January 1968. The foundation settlement is plotted as a function of time in plate 6.

- 26. The rate of settlement from March 1967 to January 1968 was practically constant. This rate, approximately 0.0037 in. per month, was about the same during June-July 1967 when 200,000 lb of dead load were applied to the foundation as it was during November 1967-January 1968 when the loading rate was only about 10,000 lb per month. This constant

rate indicates a gradual adjustment of the well-graded coral sand and coral rock underlying the foundation. A 5-ft-thick coral rock lense, which is located at a depth of about 5 to 10 ft in all South Pacific coral atolls, could be an influencing factor in the magnitude of settlement rate and eventual total settlement. However, the constant settlement rate could indicate that the initial stress exerted on the subsurface materials by the concrete ring-beam foundation itself, approximately 900 psf, was more influential in determining its settlement characteristics than was the dead load stress applied by the superstructure, which is a total of approximately 200 psf if it can be assumed that the load is applied uniformly over the entire loading surface of the ring-beam foundation.

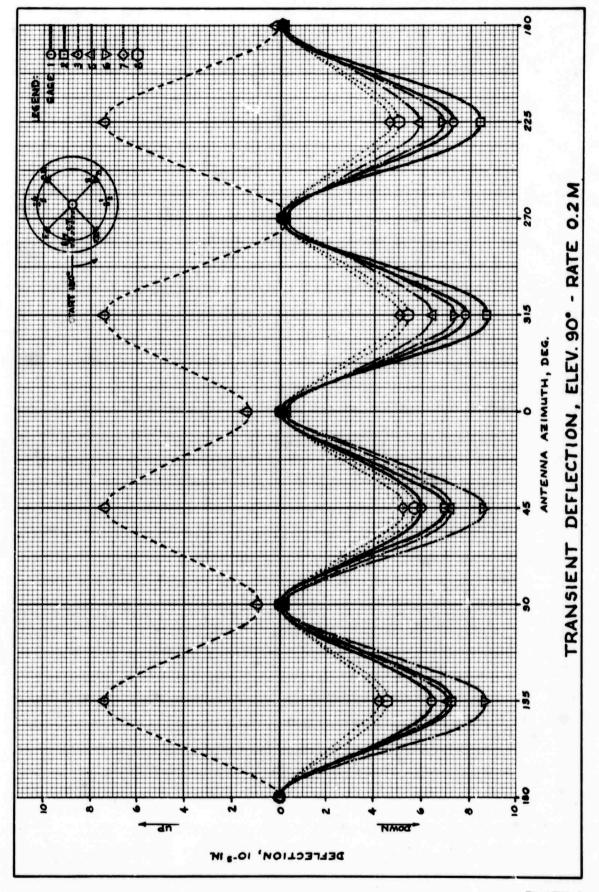
PLATE 7

plates 7 and 8 for elevations of 90 deg and 10 deg, respectively. Gage 3 deflections plotted above the zero-deflection line because at the starting azimuth of 180 deg, gage 3 was located directly under a bogie, whereas the other gages were located halfway between bogies. The plots indicate that the transient deflections were almost identical during these two tests. The smallest peak deflection during the 90-deg-elevation 0.2M test was at gage 7 (cable tunnel) due to passing of the front nondrive bogie and was approximately 0.0044 in. The maximum deflection during this test occurred at gage 2 (between two ribs) due to passing of the back drive bogie and was approximately 0.0088 in. The difference in peak deflections caused by the lightest (front nondrive) and heaviest (back drive) bogie passing over any one gage was about the same at all gages (approximately 0.0009 in.) except for gages 7 and 8, which indicated about half this difference. Very little variation was noticed in the deflections of each gage due to different rates of azimuth rotation. To illustrate this, the deflections of gages 2, 3, and 7 were plotted as a function of antenna azimuth in plate 9 for azimuth rotation rates of 0.2M and 1.0M with a constant elevation of 90 deg, and in plate 10 for rates of 0.2M and 1.2M with an elevation of 10 deg.

which at that azimuth is located halfway between two bogies. According to the data presented in plate 7, at an azimuth of 45 deg gages 1 and 2 are located under the lightest bogie, because they have their smallest peak deflection (with respect to their other peak deflections) at this azimuth, gage 3 is located halfway between the lightest and second lightest bogies, gages 5 and 6 are located under the second heaviest bogie, and gages 7 and 8 are located under the heaviest bogie. It should be reiterated that the heavy bogies are the two back bogies that transmit approximately 55 percent of the dead load to the foundation, and the two light bogies are the front bogies. The azimuth drive mechanisms add slightly more load to one of the front and one of the back bogies.
